INTERSTATE COMMERCE COMMISSION

THIRTIETH ANNUAL REPORT

DIRECTOR  
BUREAU OF LOCOMOTIVE INSPECTION

JUNE 30, 1941

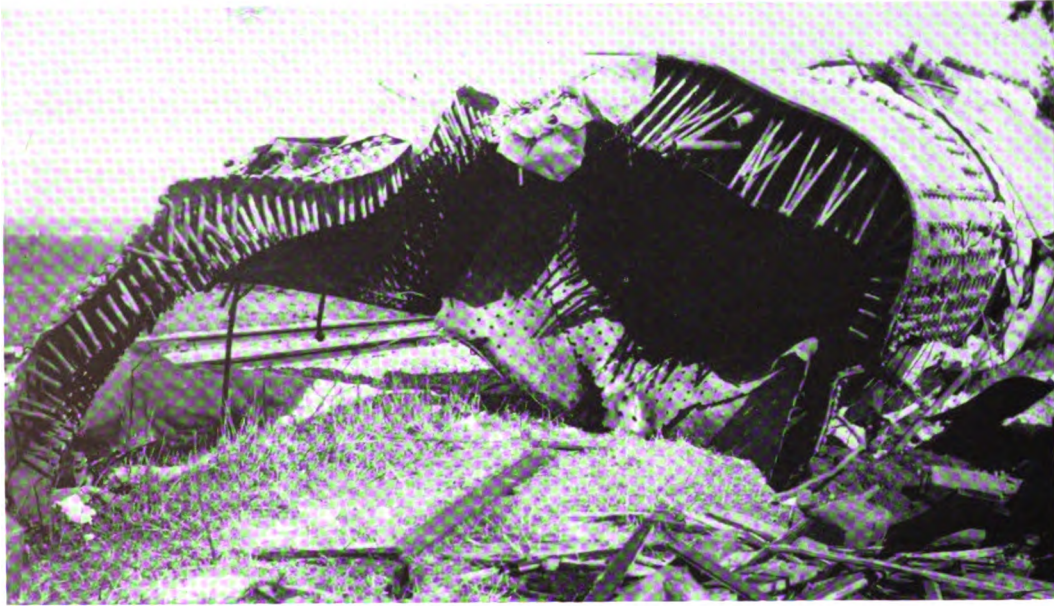
PLATE 4.

Plate 4 shows the result of an explosion caused by overheating of the crown sheet due to low water. Four employees were killed and one nonemployee was injured in this accident. The force of the explosion tore the boiler from the running gear and it was hurled forward and alighted in reversed position, striking the smokestack, feed water heater, and front sand dome on the outer rail of an adjacent siding, then rolled to the left and came to rest in an upright position 107 feet ahead and 40 feet to the left of the point of explosion. Parts of the wreckage were blown for various distances up to 562 feet from the point of the explosion.

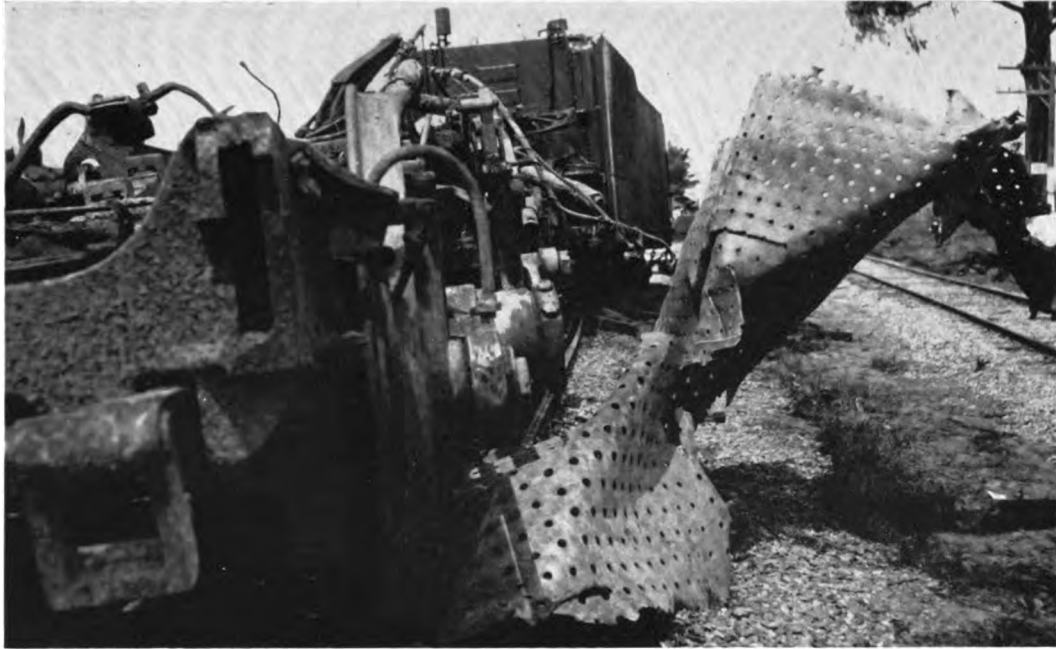
PLATE 5.

Plate 5 shows the running gear and tender after the explosion of the boiler shown in plate 4. The front driving wheel is resting on part of the crown sheet which, together with parts of the firebox casing sheets and right and left firebox side sheets, was blown from the back end of the boiler and came to rest on the track 491 feet forward of the point of explosion. The main frame is blown forward of the front driving wheel. The locomotive was a 4-8-8-2 type, oil fired designed to operate with cab end first.

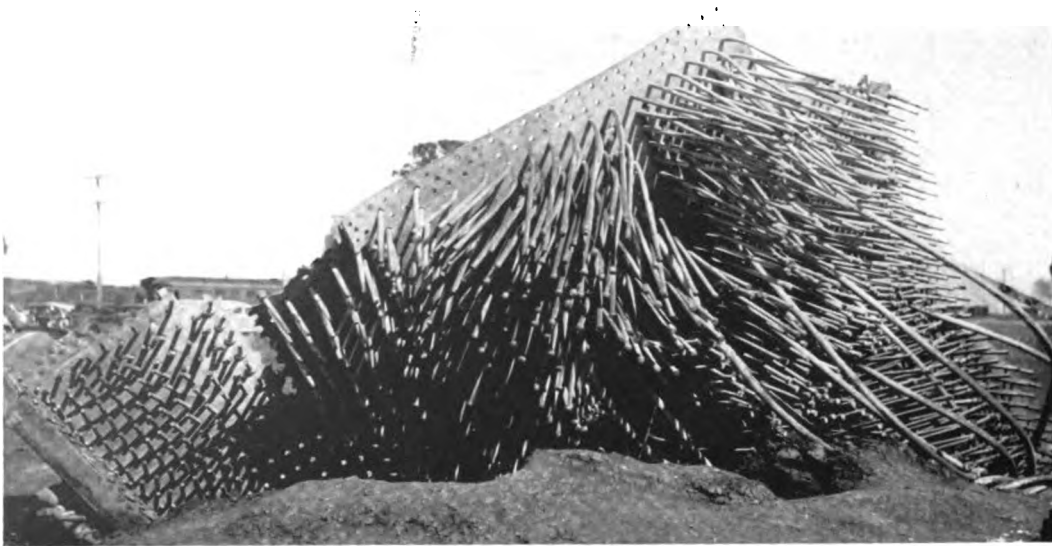
PLATE 6.

Plate 6 shows parts of the casing or outside sheets of the firebox after the explosion of the boiler shown in plate 4. These parts, estimated to weigh between 14,000 and 16,000 pounds, were blown 324 feet diagonally forward and 293 feet to the right of the track.
