CHIEF INSPECTOR
BUREAU OF LOCOMOTIVE INSPECTION

FOR THE FISCAL YEAR
ENDED JUNE 30, 1920

ANNUAL REPORT OF THE CHIEF INSPECTOR OF LOCOMOTIVE BOILERS.

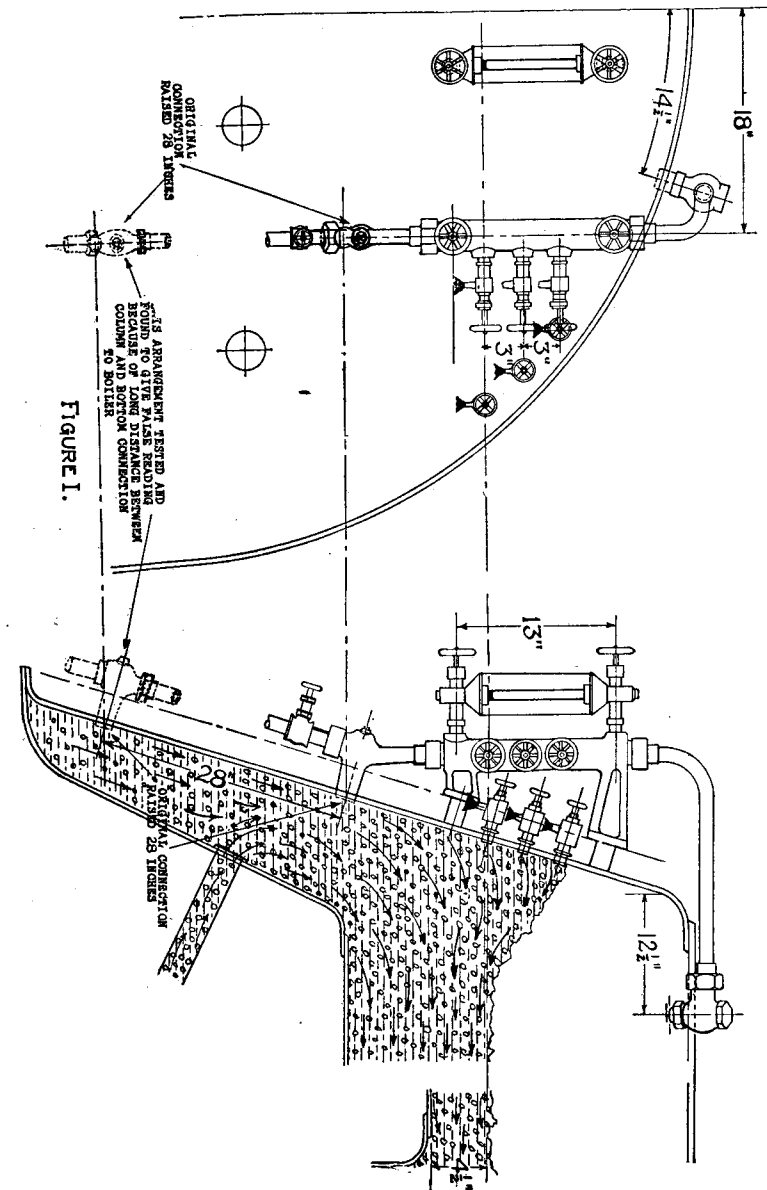
It having been concluded that the false registration of the gauge cocks when screwed directly in the boiler back head and the agitation of the water in the water glass when top connection is made near the knuckle were due to the rapid circulation of the water upward, carrying it a considerable distance above the level farther ahead, a number of locomotives were equipped with water columns, as shown by figure 1.

These locomotives were of the Santa Fe type, equipped with superheaters, stokers, used bituminous coal for fuel, carried 180 pounds steam pressure, had fire box 132 inches long and 96 inches wide, with

brick arch supported by four arch tubes and back head sloping 15° from vertical.

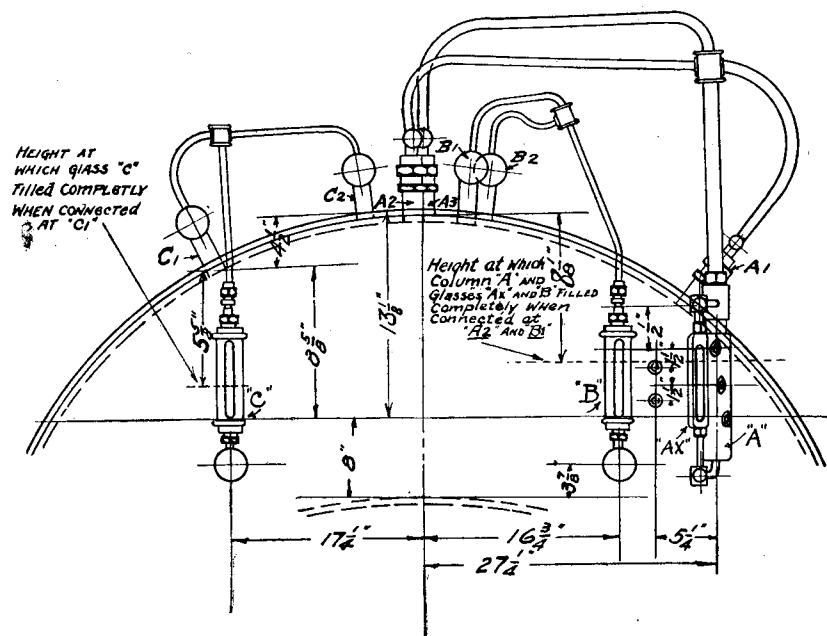
FIGURE II.

Numerous observations were made on a number of locomotives of the same type, for the purpose of comparing the action of the water in the gauge cocks and water glasses as originally applied and after certain changes were made. For the sake of brevity, however, the tests made on only one of these locomotives will be

described, inasmuch as the results obtained were the same in all cases.

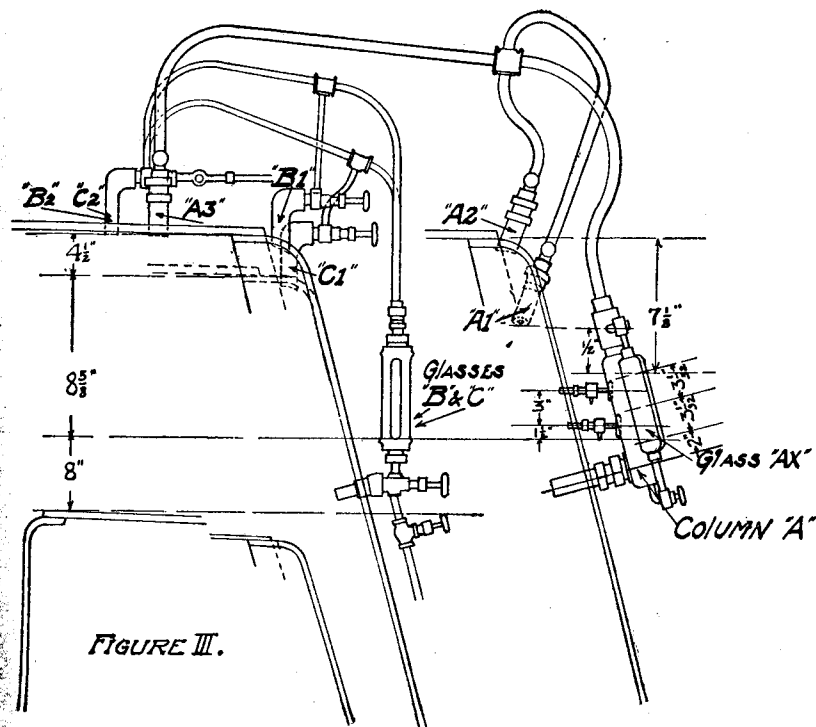
FIGURE III.

When glass C communication was changed from C1 to C2 the water would instantly recede from out of sight at top to a level of $2\frac{1}{2}$ to 3 inches and give a corresponding reading with column A and glasses Ax and B, which was true at all times when all connections were made ahead of back knuckle, regardless of the condition of service or the level of water in the boiler.

It was noted on one occasion, with column A connecting at A1, glass B connected at B2, and glass C connected at C1, the locomotive moved to a left-hand curve, at which time water glass B registered 2 inches of water while column A and glasses Ax and C were completely filled.

By referring to figure 3 it will be noted that connections to water glasses were made to the boiler through ell connections. In changing the Street ells from their original location on the back head to the location shown at B2 and C2, the C2 connection was tapped so as to drain thoroughly, while B2 was leaned sufficiently to cause a trap to be formed. This trap caused the water in B glass to rise 2 to 3 inches higher than that registered by the left glass, and when this trap was removed the water indication in all three glasses corresponded. This condition has been found in a number of the locomotives under in-

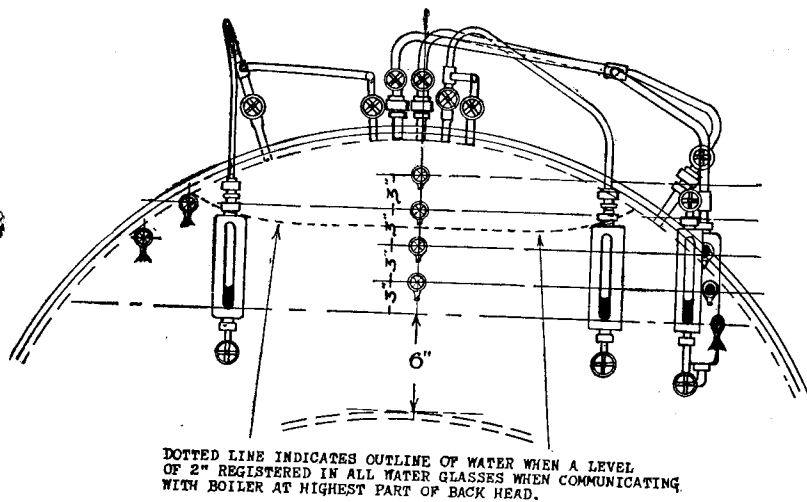
FIGURE IV.

During two round trips many readings were taken while the locomotive was in operation. It will be noted, by referring to figures 4 and 5, that with 2 inches of water showing in all glasses and one gauge of water in the column, the gauge cocks applied on the left side of the boiler head in the usual manner indicated full water while No. 1 tube indicated strong flutter at a 12-inch adjustment, No. 2 tube indicated a strong flutter at a 9½-inch adjustment, and No. 3 tube showed an occasional flutter at the back head, showing a rise of water at the back head of approximately 7 inches above that being

The dotted line in figure 4 indicates what we believe to be the general outline assumed by the water where it reaches a greater height on each side than at the vertical center line of the boiler. It was found during these tests that with the top connection to the water column connected at its original position the column would entirely fill when 4 to 5 inches of water was reached in the column glass. When changing from this connection to the highest point on the back head, the water would immediately recede to 4 inches, but when changing from one connection to the other on the highest part of the boiler, the readings were not affected, which indicated that dry steam was being obtained both at the back knuckle and further ahead, due, no doubt, to the increased dry steam space in the back end of this boiler and the exceedingly good water used for locomotive purposes in this district.

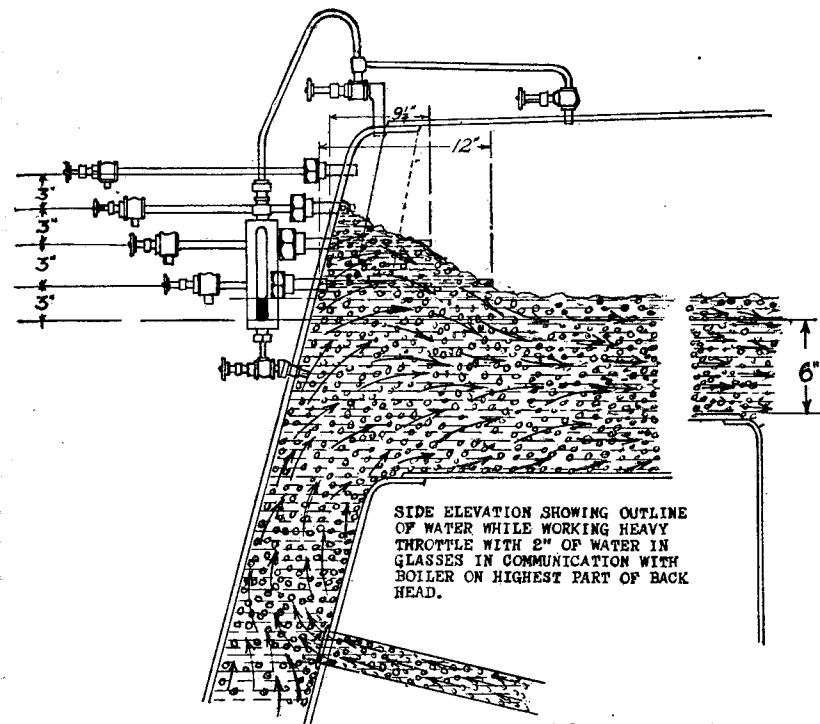
FIGURE V.

It was found that approximately the same conditions were disclosed as those developed in other tests, except that the outline of water reached a higher elevation and greater proportions at the backhead than those illustrated by figure 5, which is no doubt due to the extremely good water used for locomotive purposes in the district where the previous tests were made.

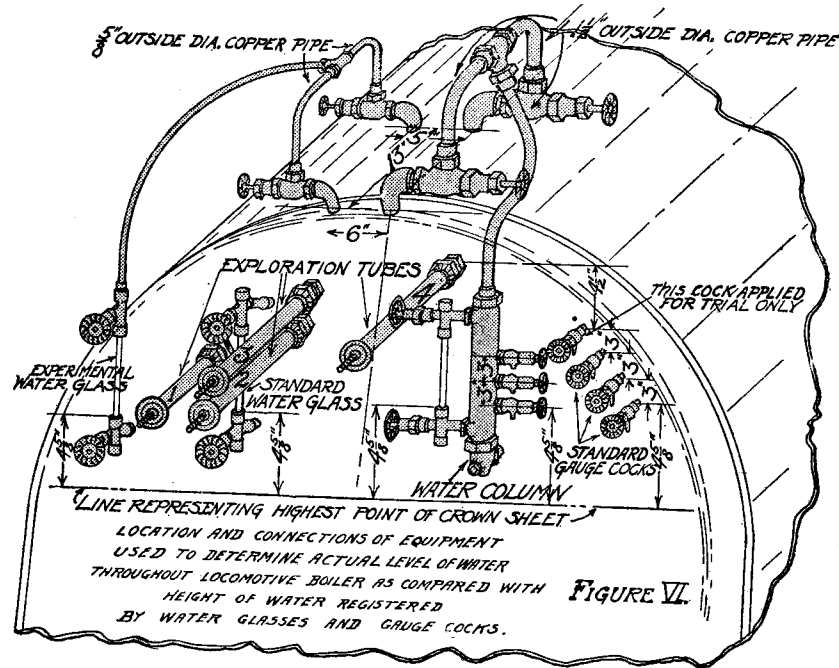
rapidly generated and simultaneously escaping from the boiler, tests were made with appliances shown by figures 6 and 7, covering a distance of 808 miles in bad water districts on approximately level track and while handling regular tonnage.

The apparatus shown by figure 6 consisted of four gauge cocks applied directly in the back head near the knuckle, one water column to which three gauge cocks and one water glass were attached, one water glass with a 9-inch reading, standard application, with both top and bottom cocks entering boiler back head direct, one water glass applied for experimental purposes with the bottom cock entering the boiler head direct and with one top connection entering the boiler head on back knuckle and one entering 13 inches ahead, and four exploration tubes or sliding gauge cocks.

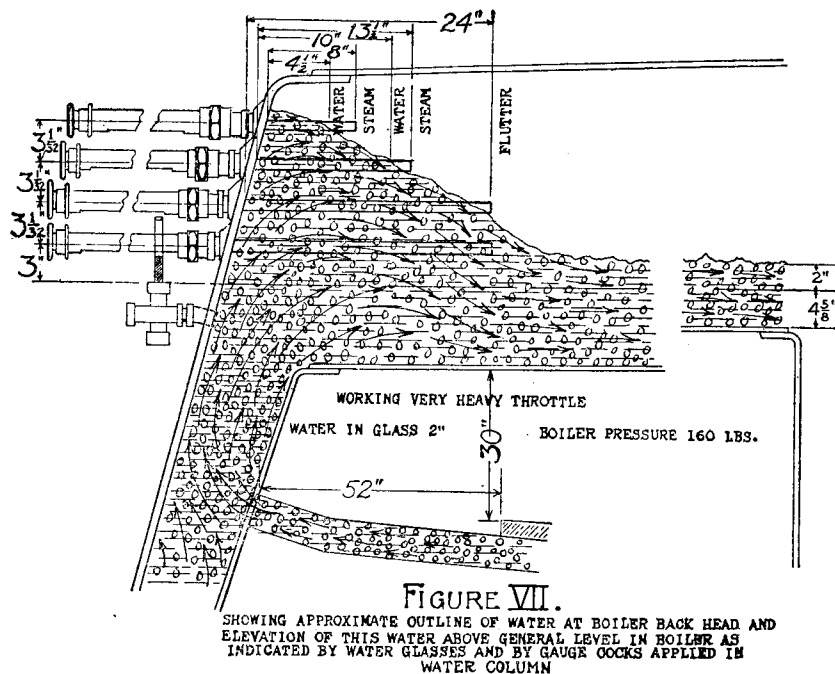
Figure 7 shows a side elevation of these exploration tubes or sliding gauge cocks entering the back head parallel to the horizontal axis of the boiler with a vertical pitch of 3½ inches, giving a total vertical reading of 10½ inches, with a horizontal adjustment of 24

It will be noted from this figure that while tube No. 1 was submerged, tube No. 2 showed a flutter of steam and water at an adjustment of 24 inches; tube No. 3 showed water at an adjustment

of 10 inches and steam at 13½ inches; tube No. 4 showed water at an adjustment of 4½ inches and steam at 8 inches. These readings were taken while the experimental water glass and water glass attached to the water column registered 2 inches of water, and the gauge cocks attached to the water column showed one gauge, while the four gauge cocks applied in the back head registered full.

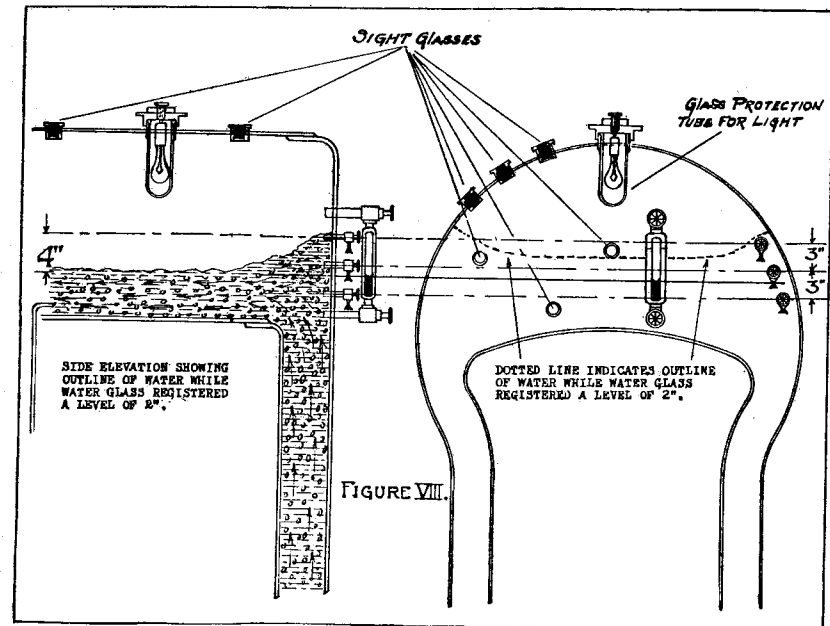
The water-indicating devices consisted of three gauge cocks spaced 3 inches apart and applied directly in the right knuckle of the back boiler head, with a vertical reading of 6 inches, and one reflex water glass with a clear reading of 7 inches and with top and bottom connections entering the boiler head direct on the vertical part 5 inches to the right of the center line. The lowest reading of the gauge cocks and water glass was 3 inches above the highest part of the crown sheet.

inserted in the top of the wrapper sheet which permitted the use of an electric light inside the boiler, which clearly illuminated the steam space over the crown sheet. Five bull's-eye sight glasses were applied over the back end of crown sheet, two over the front of crown sheet, and three in the vertical back head, so that the action of the water in this part of the boiler could be seen while under steam pressure. The arrangement of these appliances is illustrated by figure 8.

The important feature to be noted is that this height of water, as seen at the back head, was approximately 4 inches at its maximum, and was registered by the gauge cocks, while at the same time it could be seen that the water glass was registering the level farther ahead over the crown sheet.

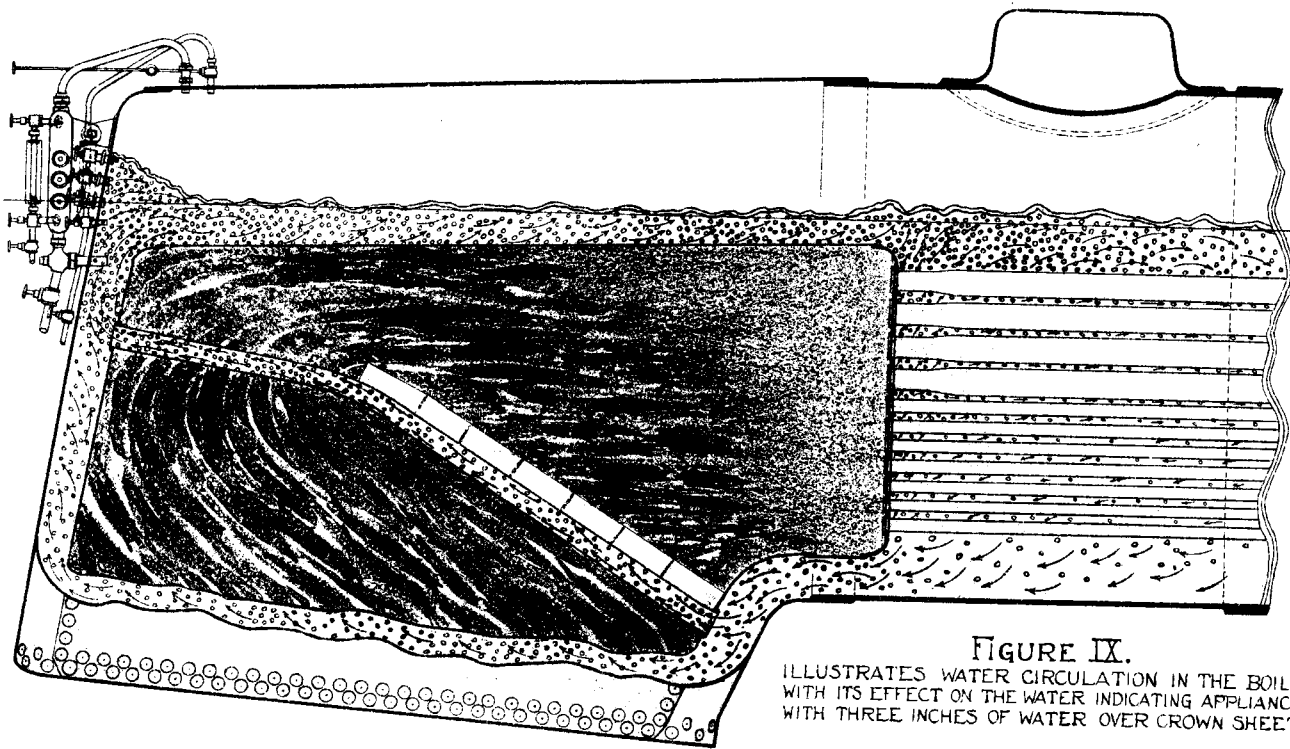
Figures 9 and 10 illustrate the circulation of water in the boiler. The feed water which enters near the front and is much lower in temperature than that in the boiler, which, due to its density and weight naturally lowers and moves toward the fire box sheets where the greatest evaporation takes place. As the water is heated it rises, due to its decreased weight, influenced by the steam bubbles rising to the surface where they explode. This circulation causes a movement of water from front to back in the lower portion of the boiler, and upward around the fire box, and from back to front in the upper portion which unquestionably takes place with sufficient rapidity to carry the water around the fire-box sheets above its natural level, due to the narrow space in the water legs, where the greatest amount of heat is applied.

Figure 9 illustrates a portion of a locomotive boiler equipped with brick arch and arch tubes where the general level of water in the boiler is 3 inches above the highest part of the crown sheet, the minimum required by law, and where the water glass, when properly applied in the usual manner, and the water glass and gauge cocks attached to a properly designed and applied water column, indicate the level of water over the crown sheet, while the gauge cocks in the back head register the water at the back head. This condition has been clearly established by the tests herein described.

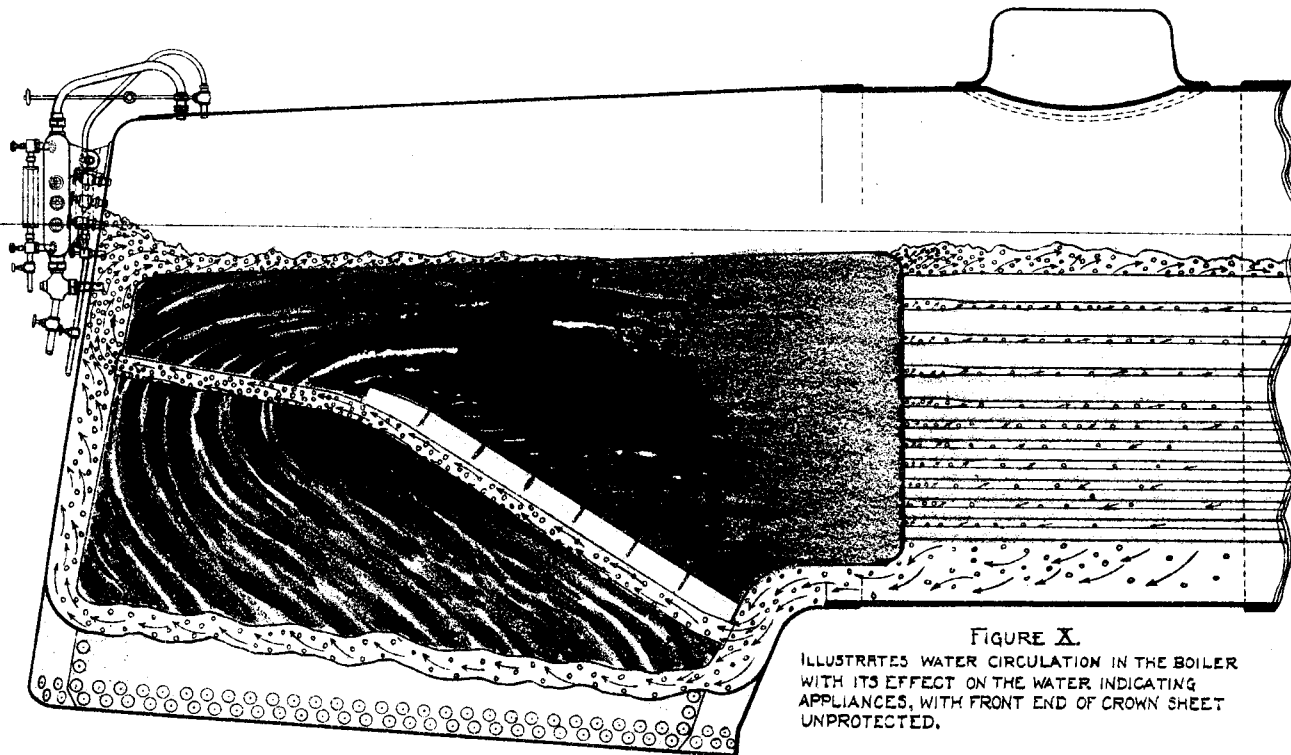
Figure 10 illustrates the same portion of a locomotive boiler and a condition which may exist where the water glass registration is ignored and the gauge cocks applied in the boiler are depended upon as registering the correct level. Since practically all enginemen have been taught to rely on the gauge cocks in preference to the water glass, this is an especially unsafe condition, and is, no doubt, the cause of many damaged crown sheets.
