CHIEF INSPECTOR
BUREAU OF LOCOMOTIVE INSPECTION

FOR THE FISCAL YEAR
ENDED JUNE 30, 1920

ANNUAL REPORT OF THE CHIEF INSPECTOR OF LOCOMOTIVE BOILERS.

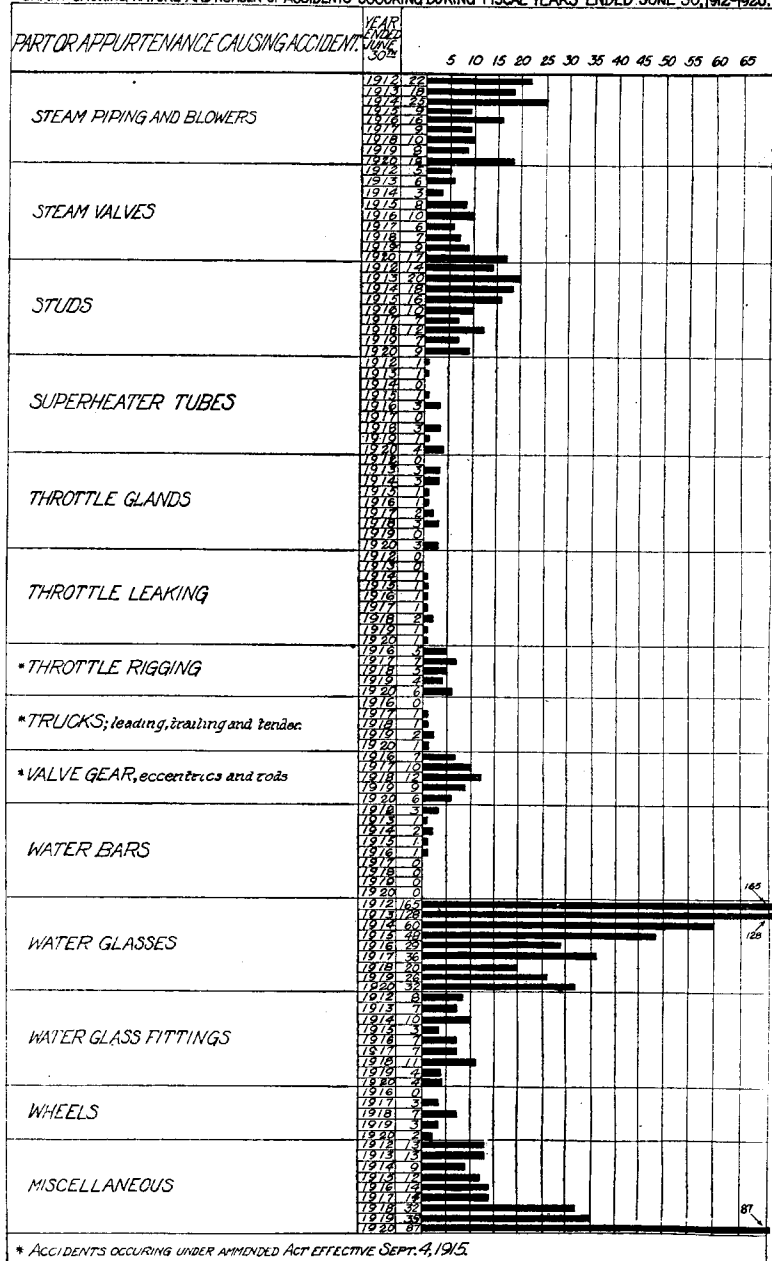
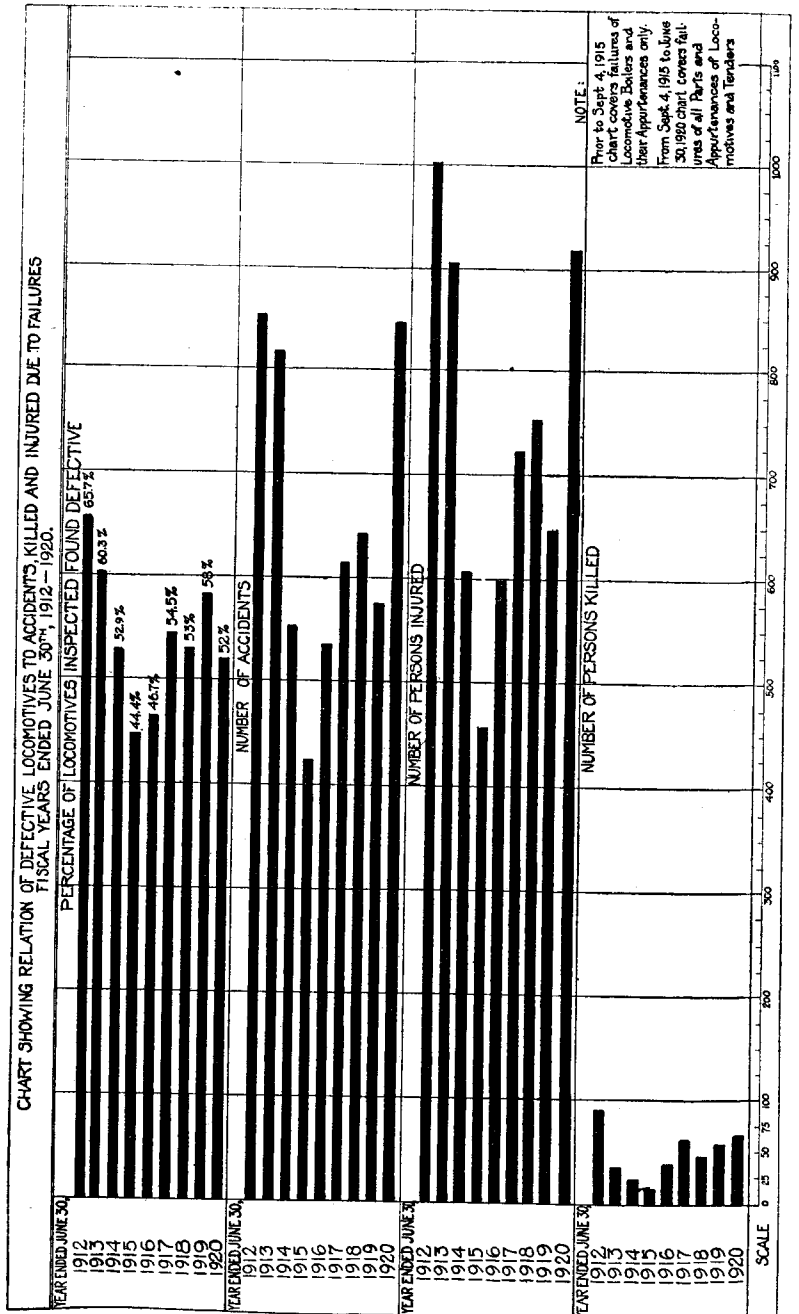
CHART SHOWING NATURE AND NUMBER OF ACCIDENTS OCCURRING DURING FISCAL YEARS ENDED JUNE 30, 1912-1920.

NOTE:
Prior to Sept. 4, 1915 chart covers failures of Locomotive Boilers and their Appurtenances only. From Sept. 4, 1915 to June 30, 1920 chart covers failures of all Parts and Appurtenances of Locomotives and Tenders.
